# Case Studies in Troubleshooting

# 01 | Submodule Offline Troubleshooting

## 02 | Calibration Process of the Arm Angle

## 03 | Sensor System Offline Troubleshooting

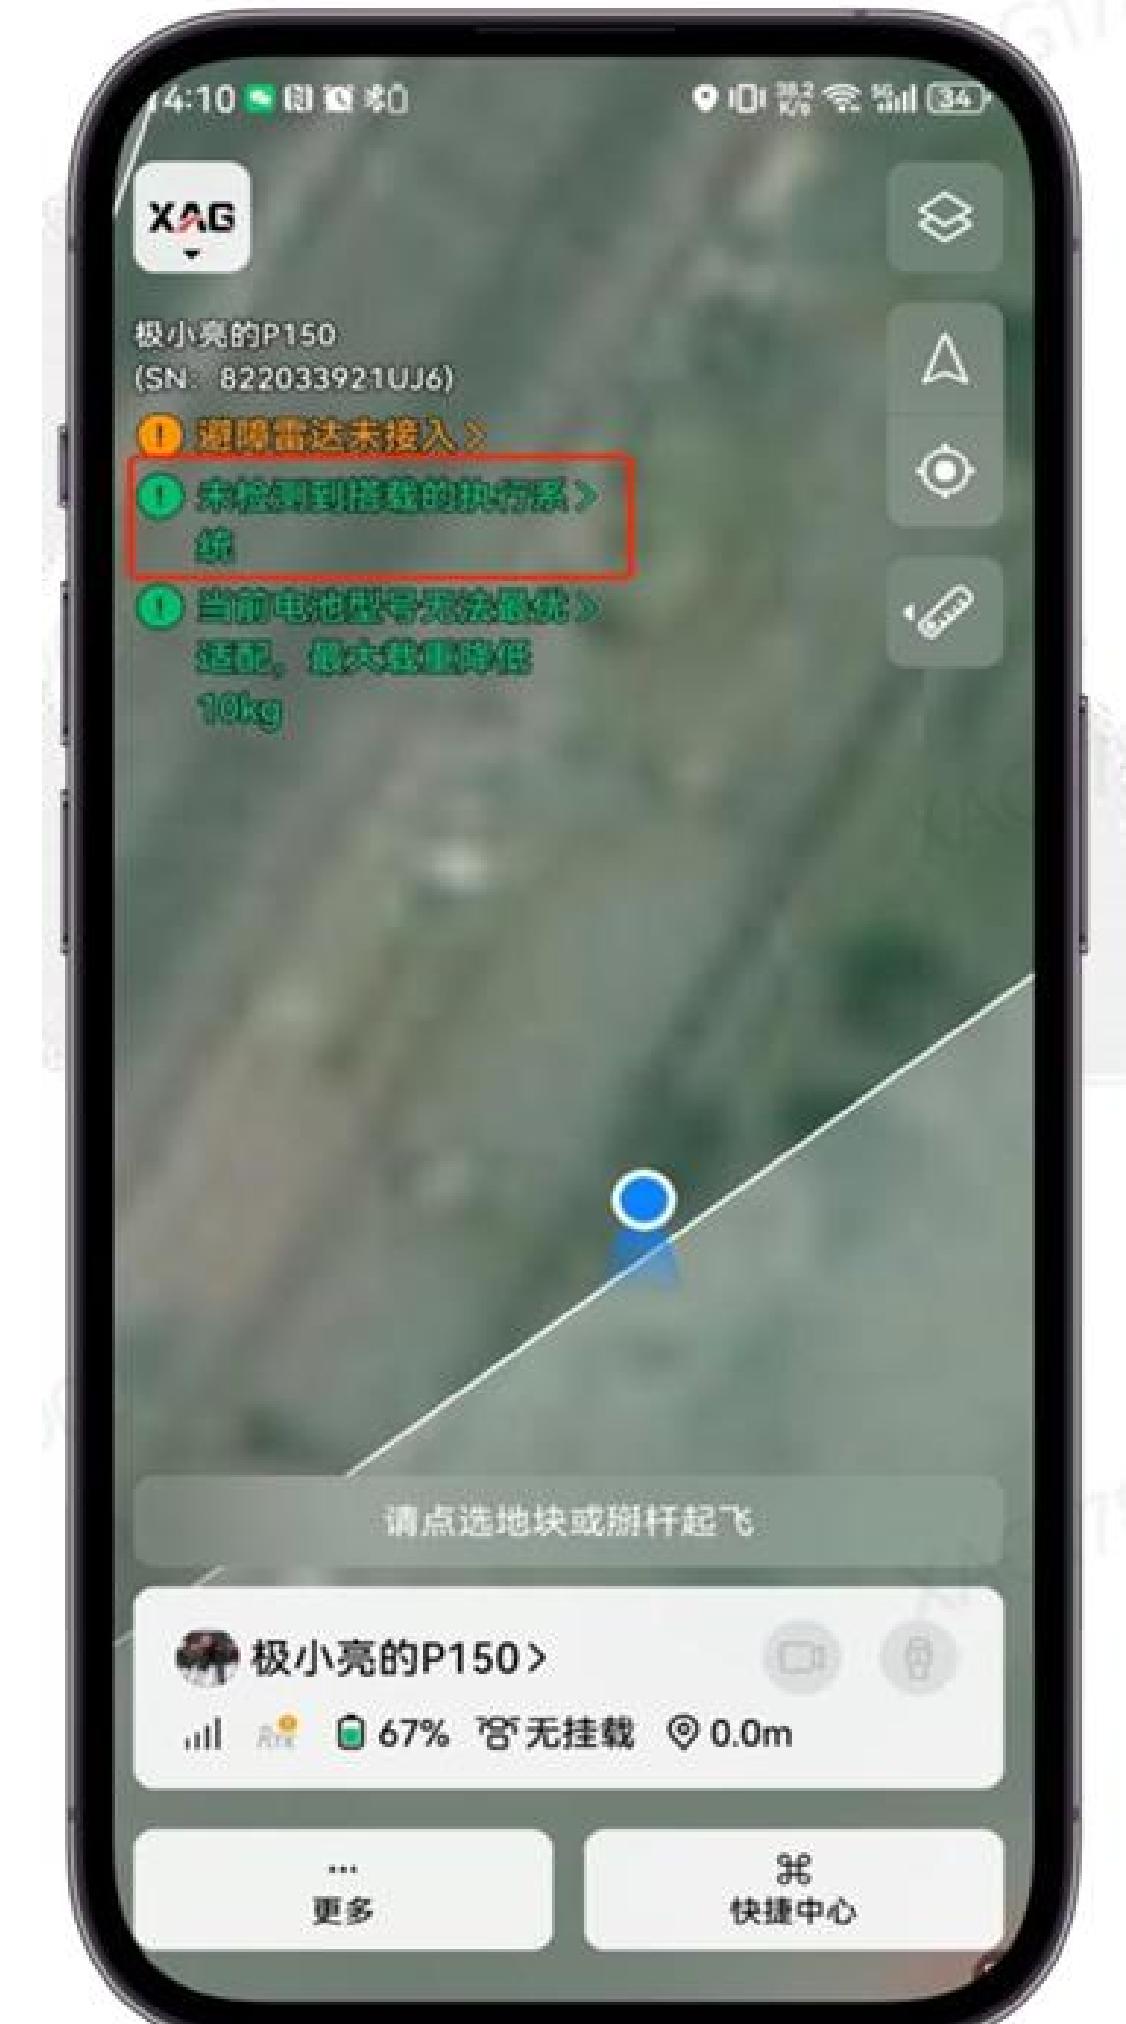
**Error displayed on APP interface:** "No application system detected".

**Error description:** Because most of the molecular modules in the execution system are abnormal, the device cannot identify the current execution system according to the combination of submodules.

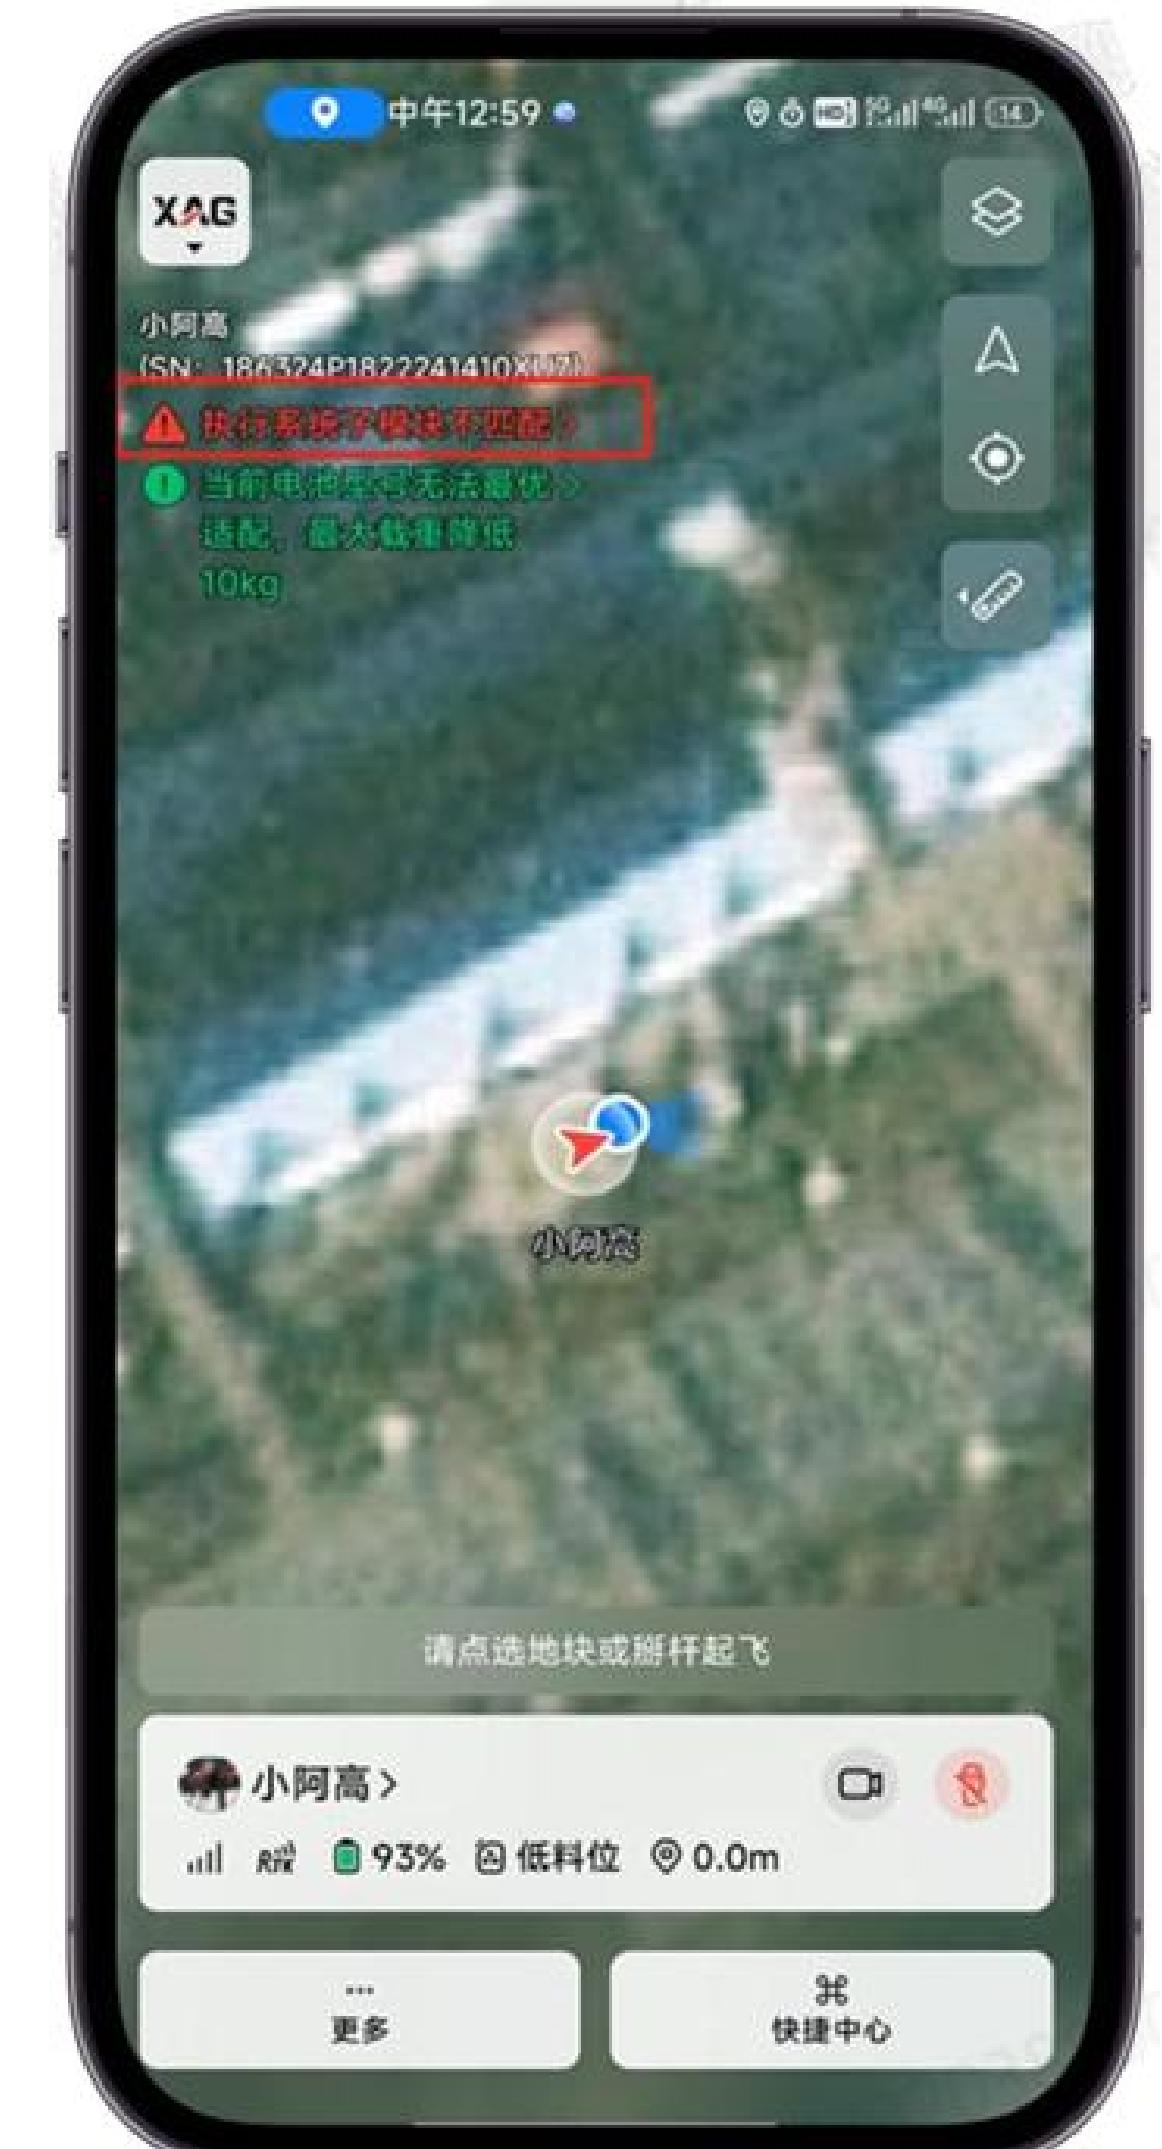
**Error displayed on APP interface: "Task System Submodule Mismatch"**

**Error description:** Partial submodules in the execution system are abnormal. The device can still determine the execution system type through the combination of normal submodules, but it cannot pinpoint which specific submodule is malfunctioning.

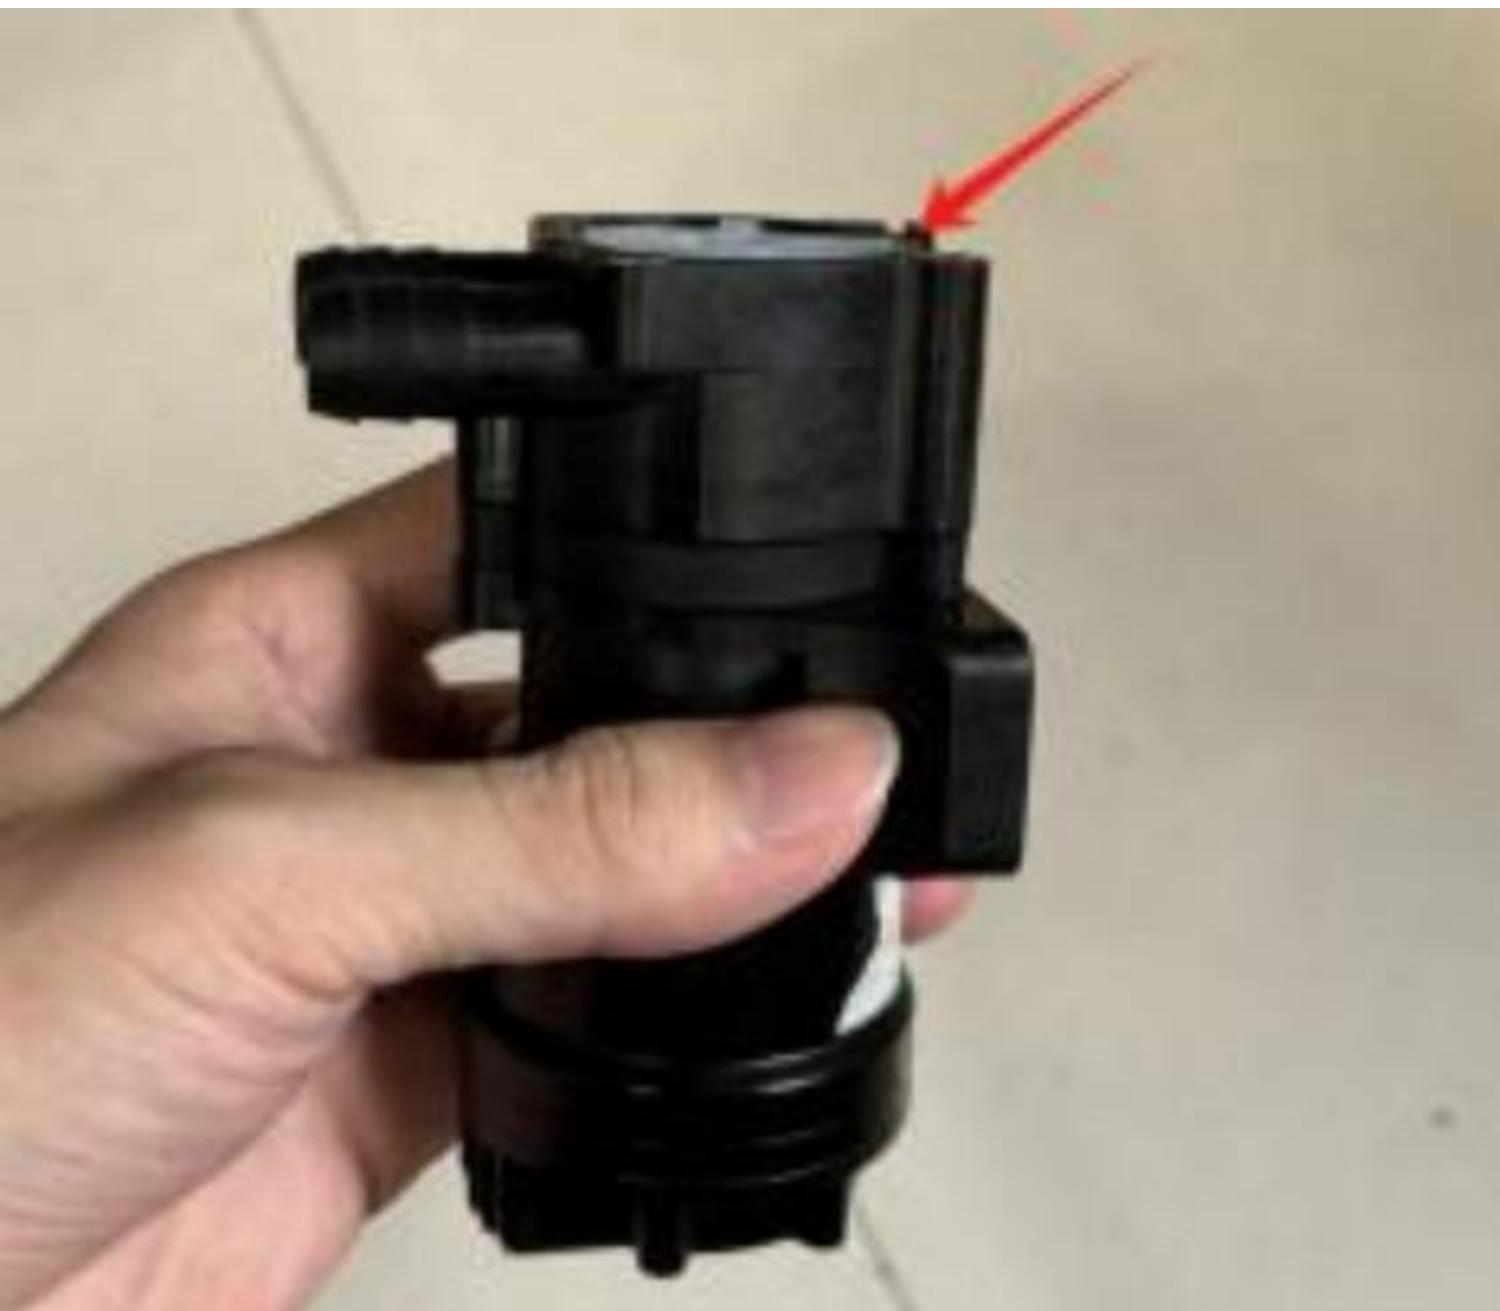
Normal impeller

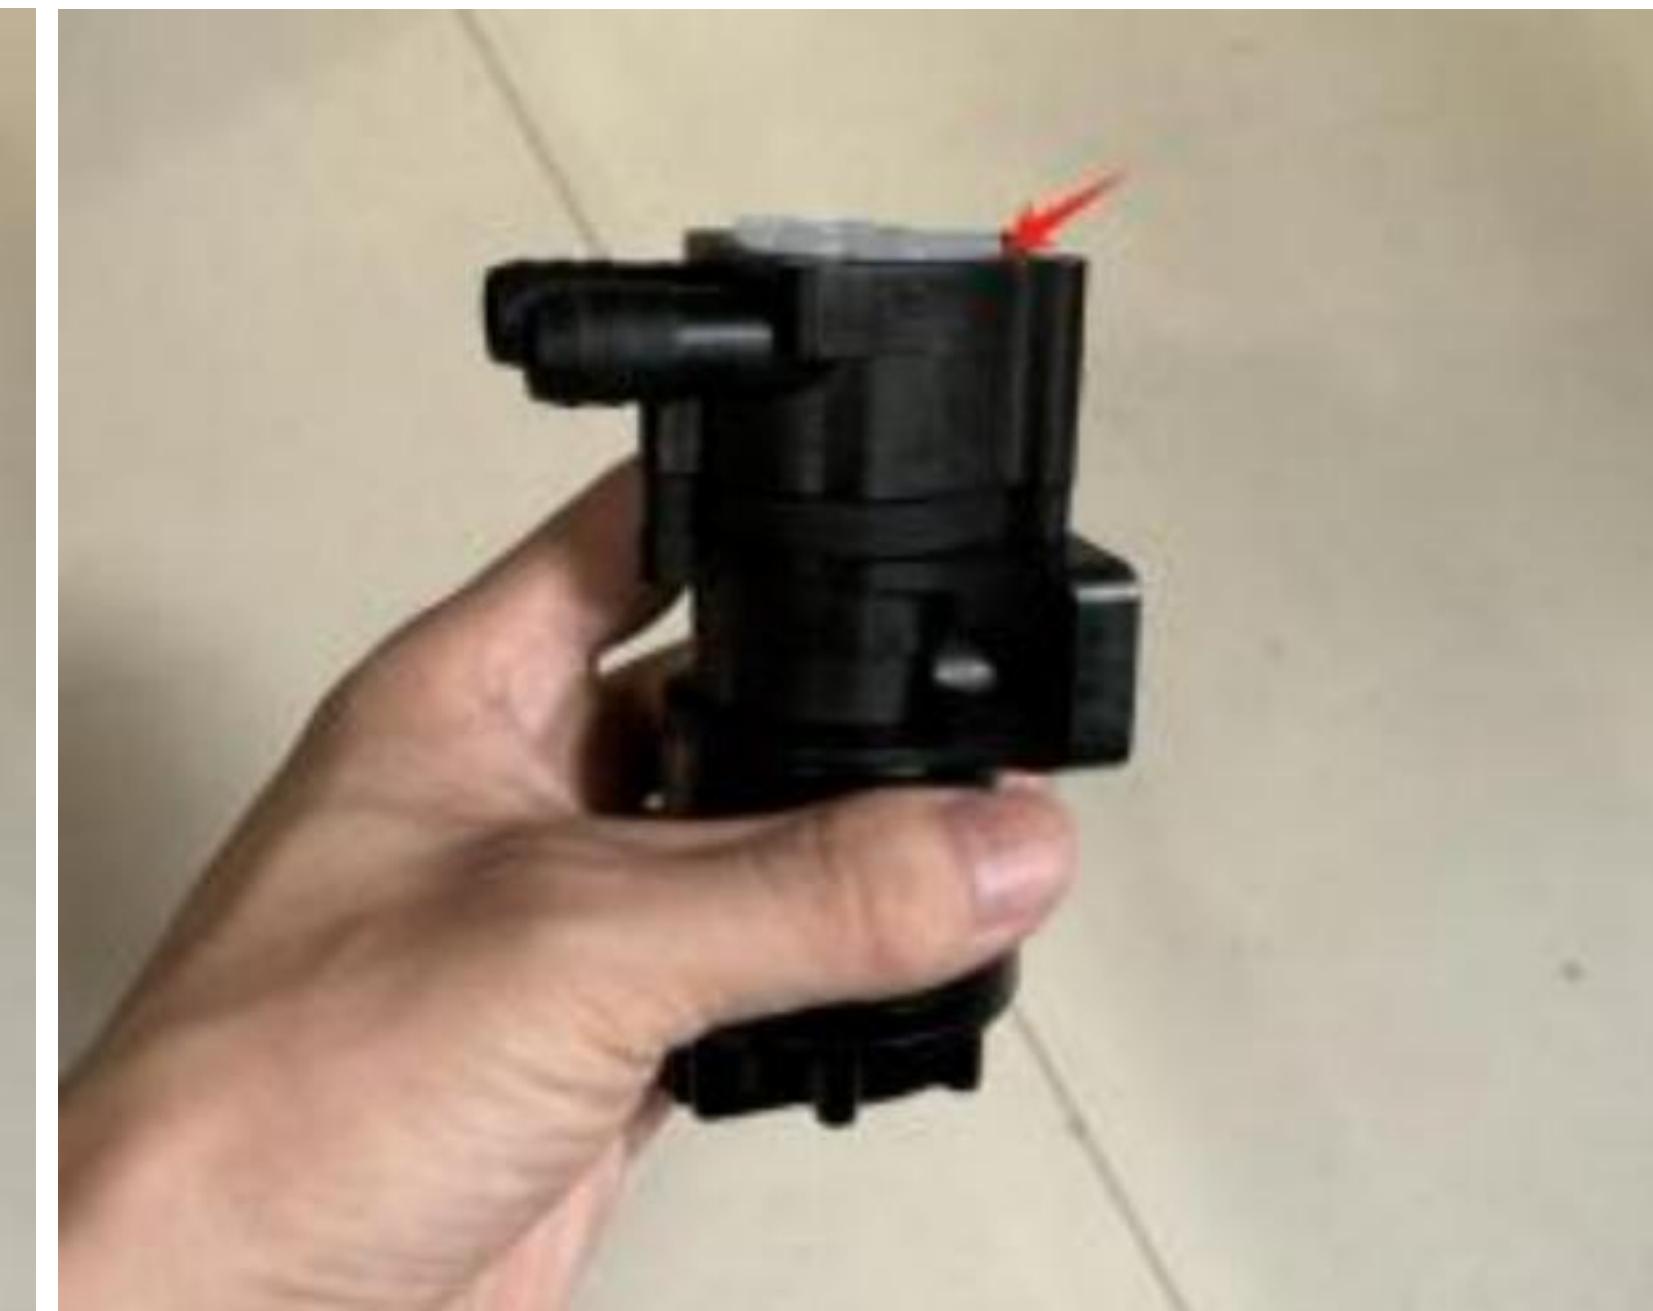
7) Check whether the impeller of the pump are faulty or if installation errors are causing uneven liquid output.

Corrosion or broken impeller or  
severe wear  
(Impeller higher than cavity)

Handling method: Replace with an impeller with low-temperature characteristics, recalibrate, and then use the pump.

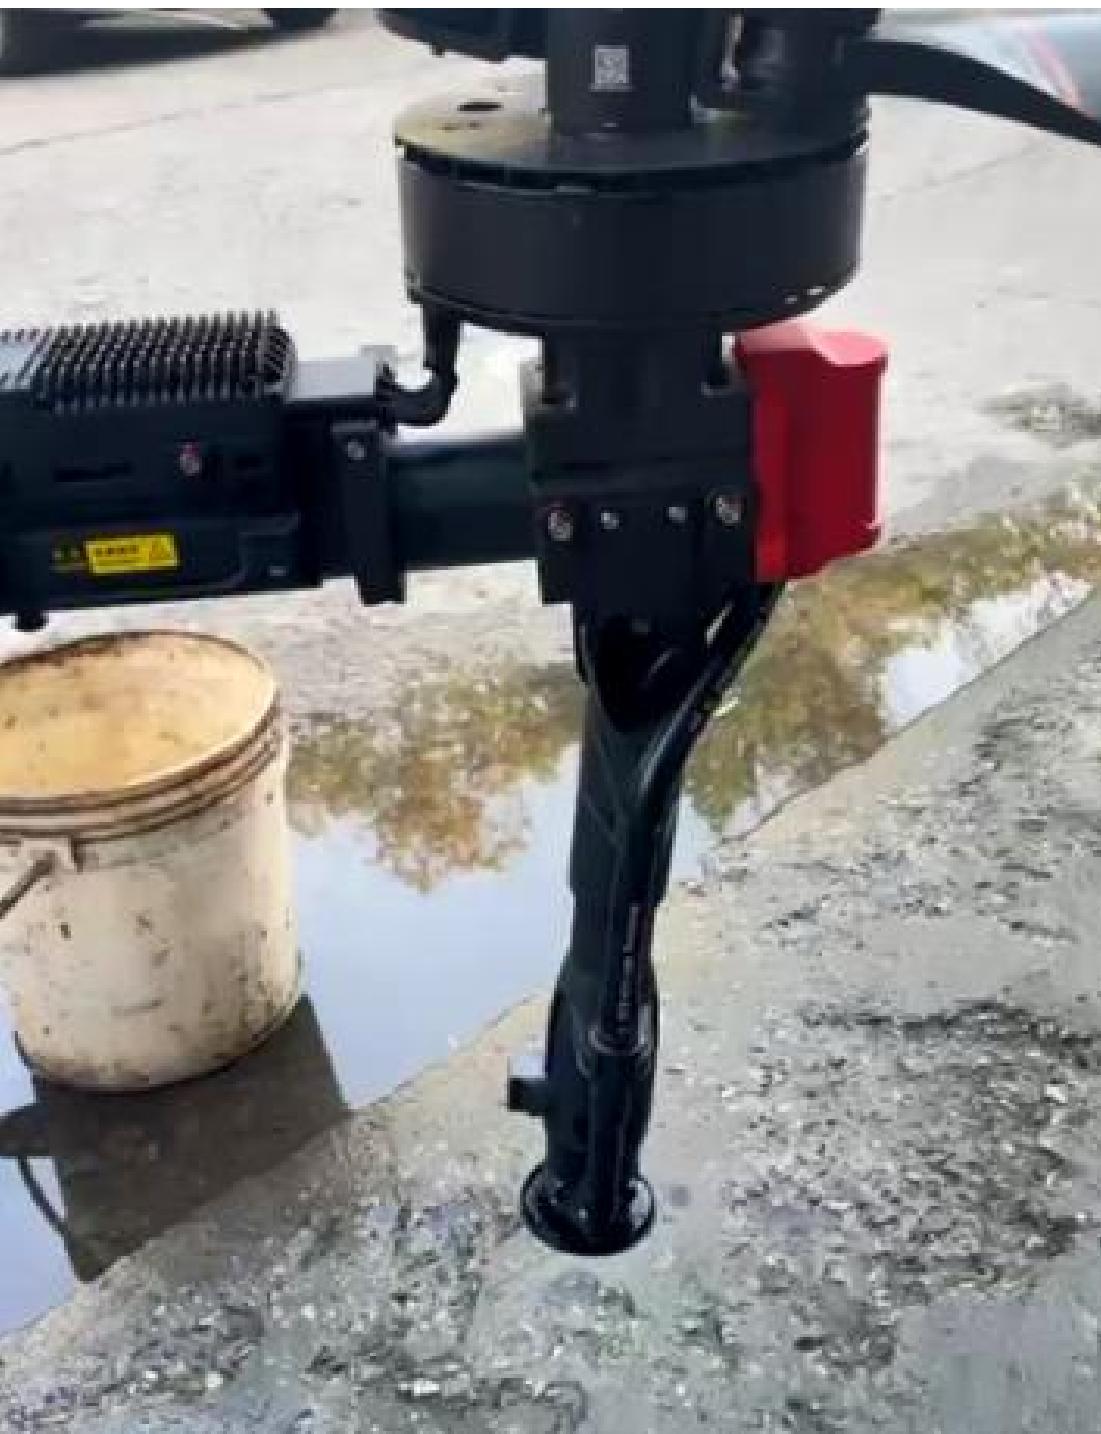
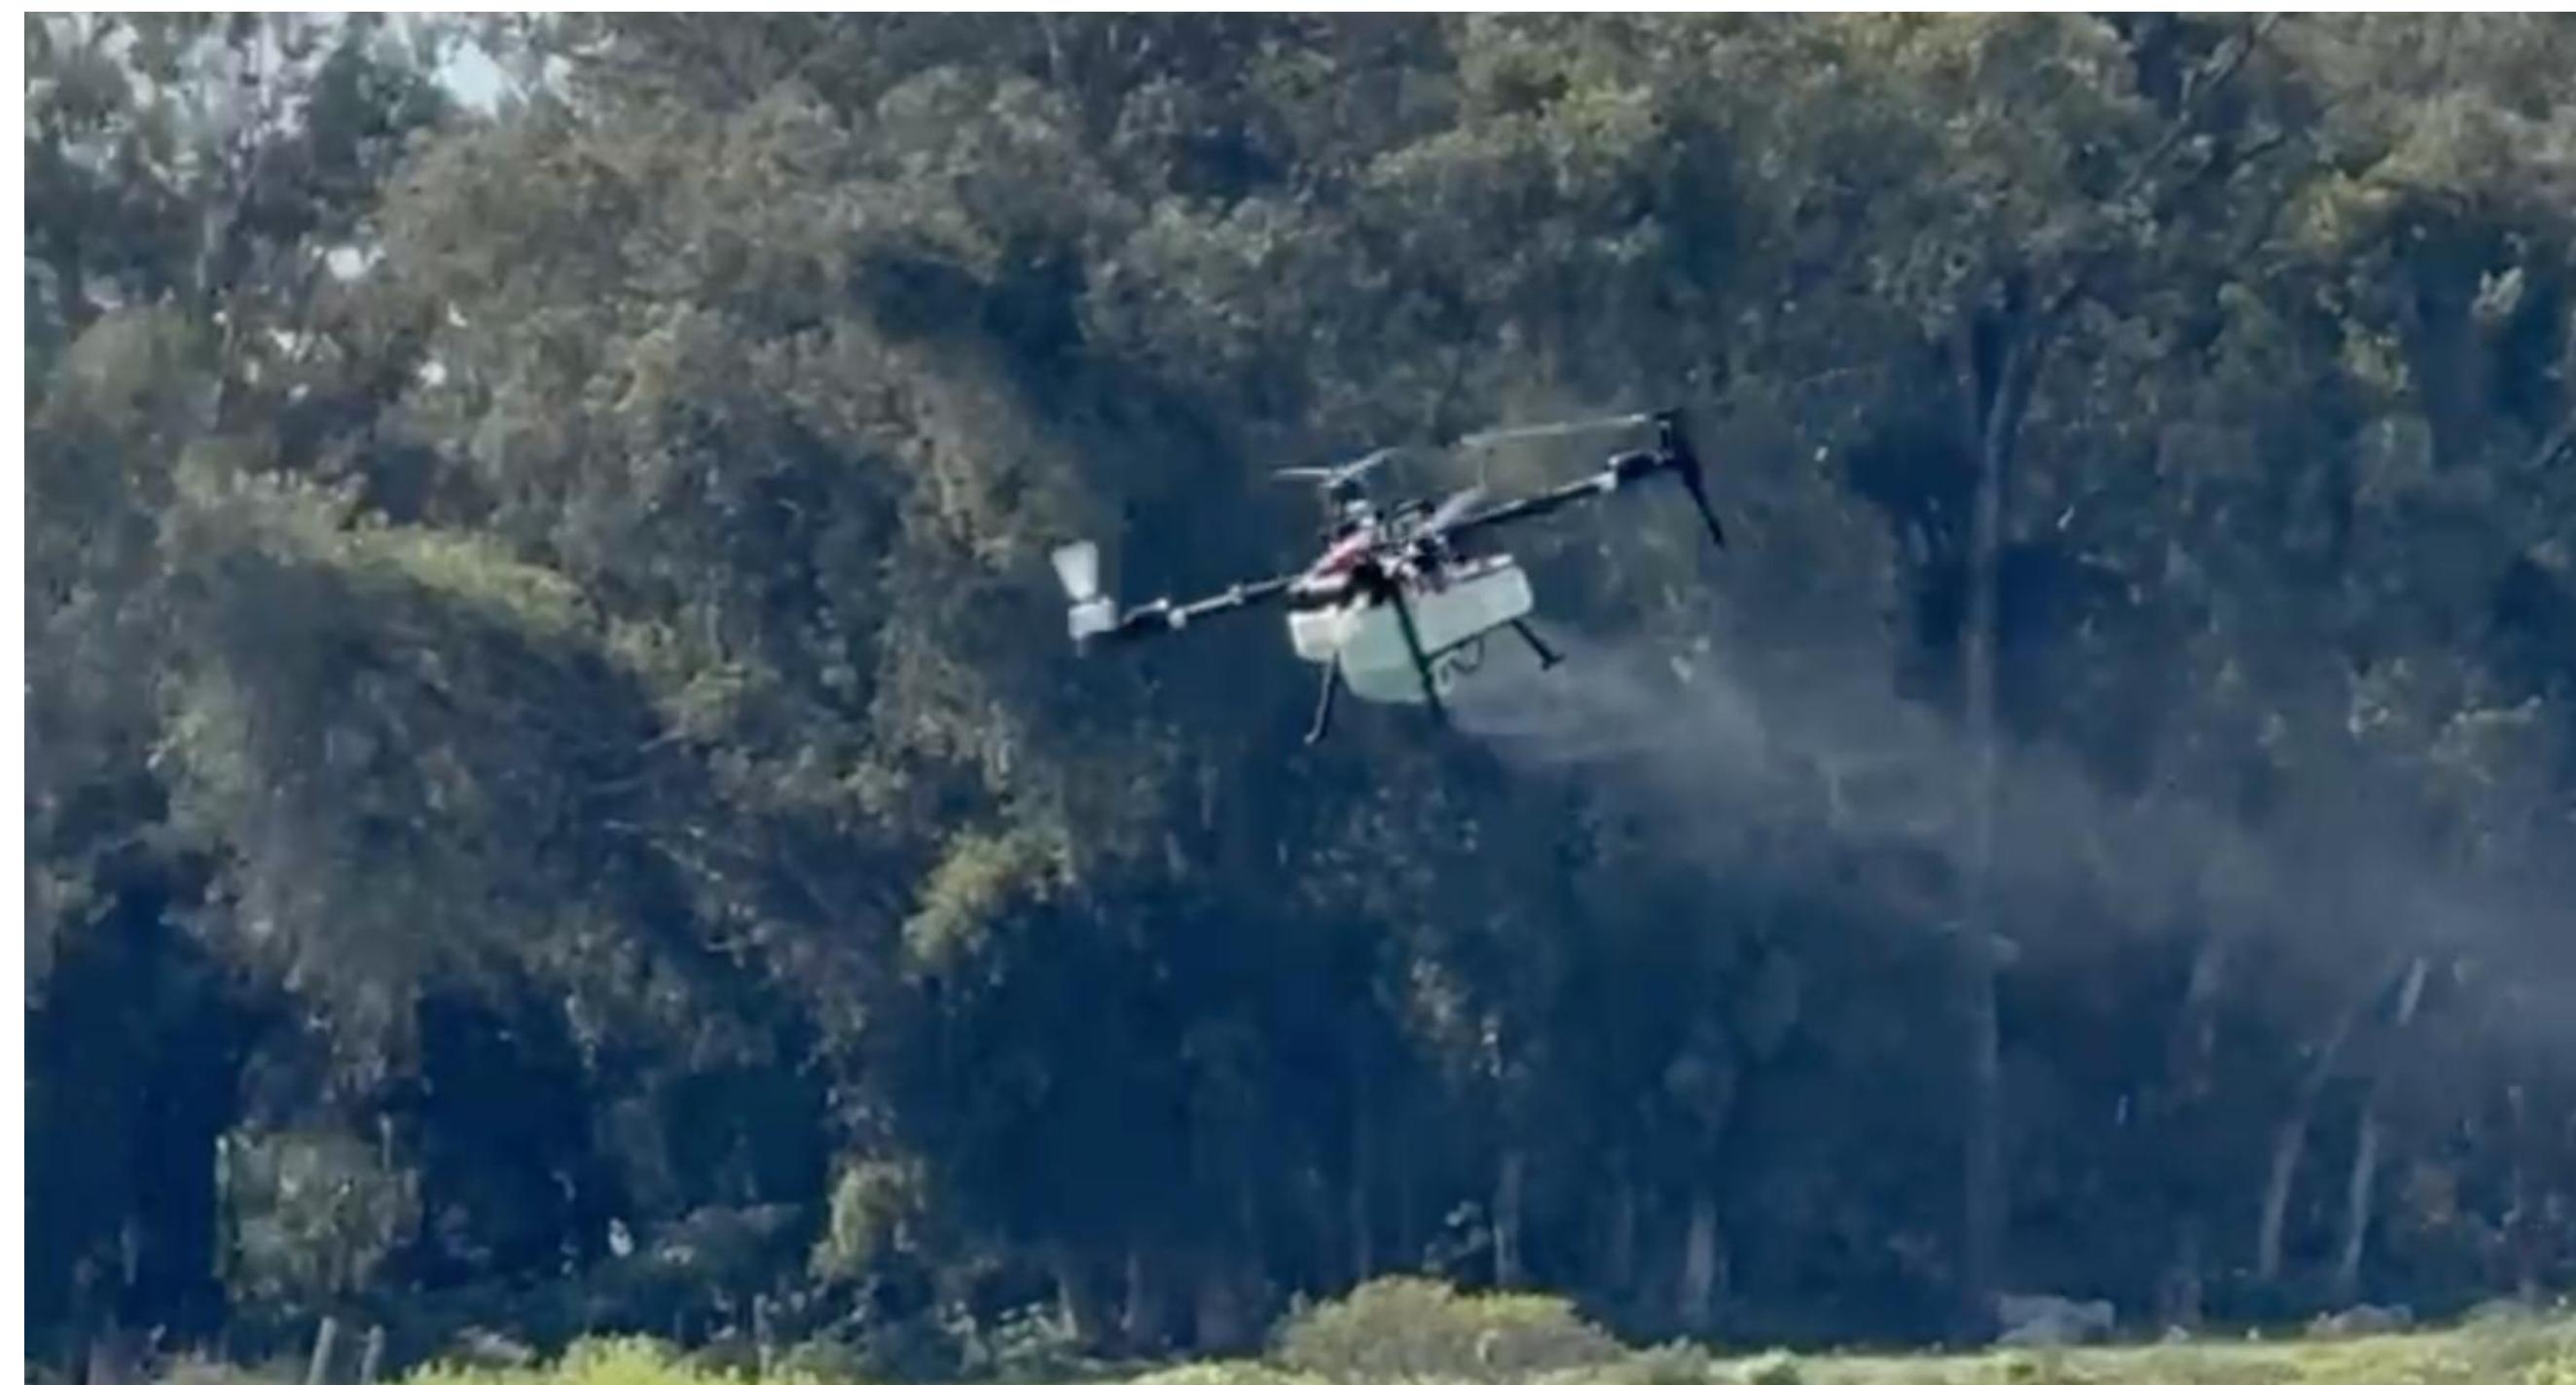
## 4.2. How to deal with the problem that the sprinkler impeller pump does not discharge water or the water output is too low?

**This usually happens with following conditions:**

- 1. New drones that were never used before.**
- 2. Drone after long time storage.**
- 3. User performed a drainage operation on the ground when the tank was completely drained. Once the tank is empty, the impeller can only pump air. Air is too light, resulting in insufficient centrifugal force and failure to form suction, which causes the pump to run dry without pumping water during low-flow operations.**

**Improvement measures:** To ensure that the pump body and pipeline are filled with water and avoid abnormal water discharge caused by residual air, the following two pipeline filling methods are recommended.

### **Method 1:** Clear water pipeline filling method

Steps: Inject at least 5L of clear water into the pump body and pipeline, and use the high-flow mode to fill water quickly. Observe the water outlet of the sprinkler. Stop filling the pipeline after both pump heads discharge water normally, and then normal dosing operations can be carried out.

### **Method 2:** Medicine liquid pipeline filling method

Steps: Directly use the medicine liquid to fill the pipeline at high flow rate, and stop immediately after the sprinkler discharges the liquid. A container can be placed under the sprinkler to catch the medicine liquid to avoid waste (For high-cost medicines)
