# Case Studies in Troubleshooting

# 01 | Submodule Offline Troubleshooting

## 02 | Calibration Process of the Arm Angle

## 03 | Sensor System Offline Troubleshooting

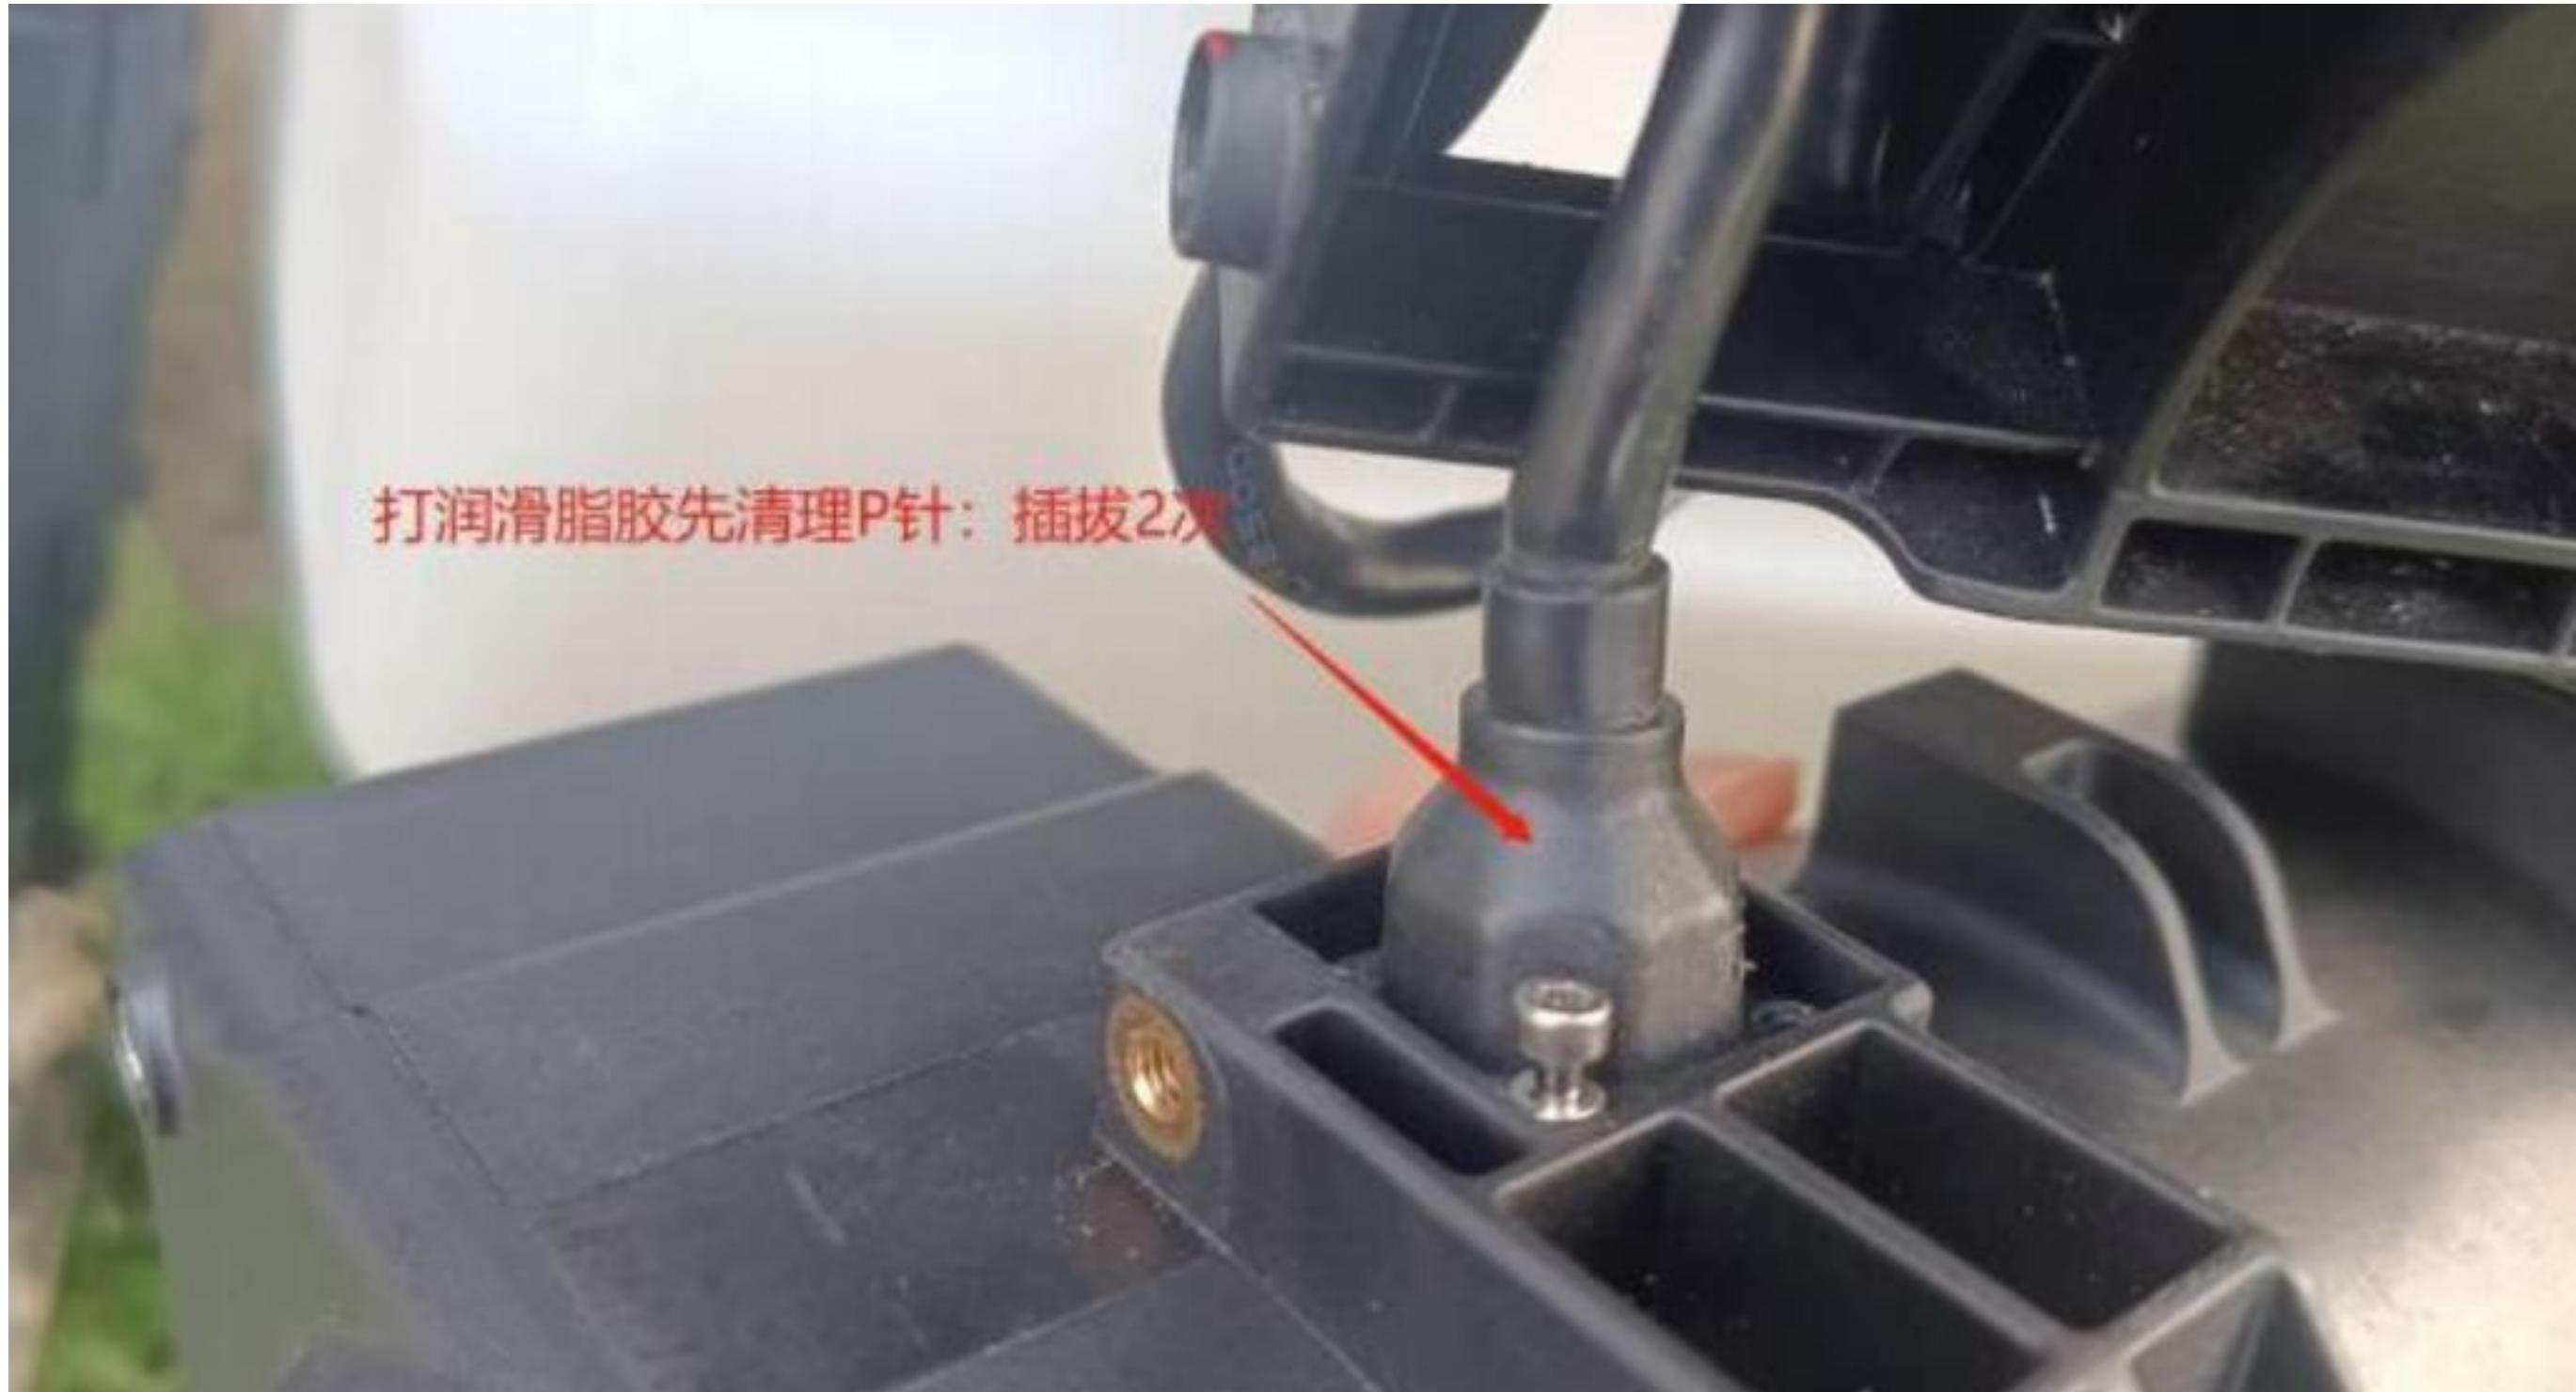
### 1. Clean connector pins (plug and unplug 2 times)

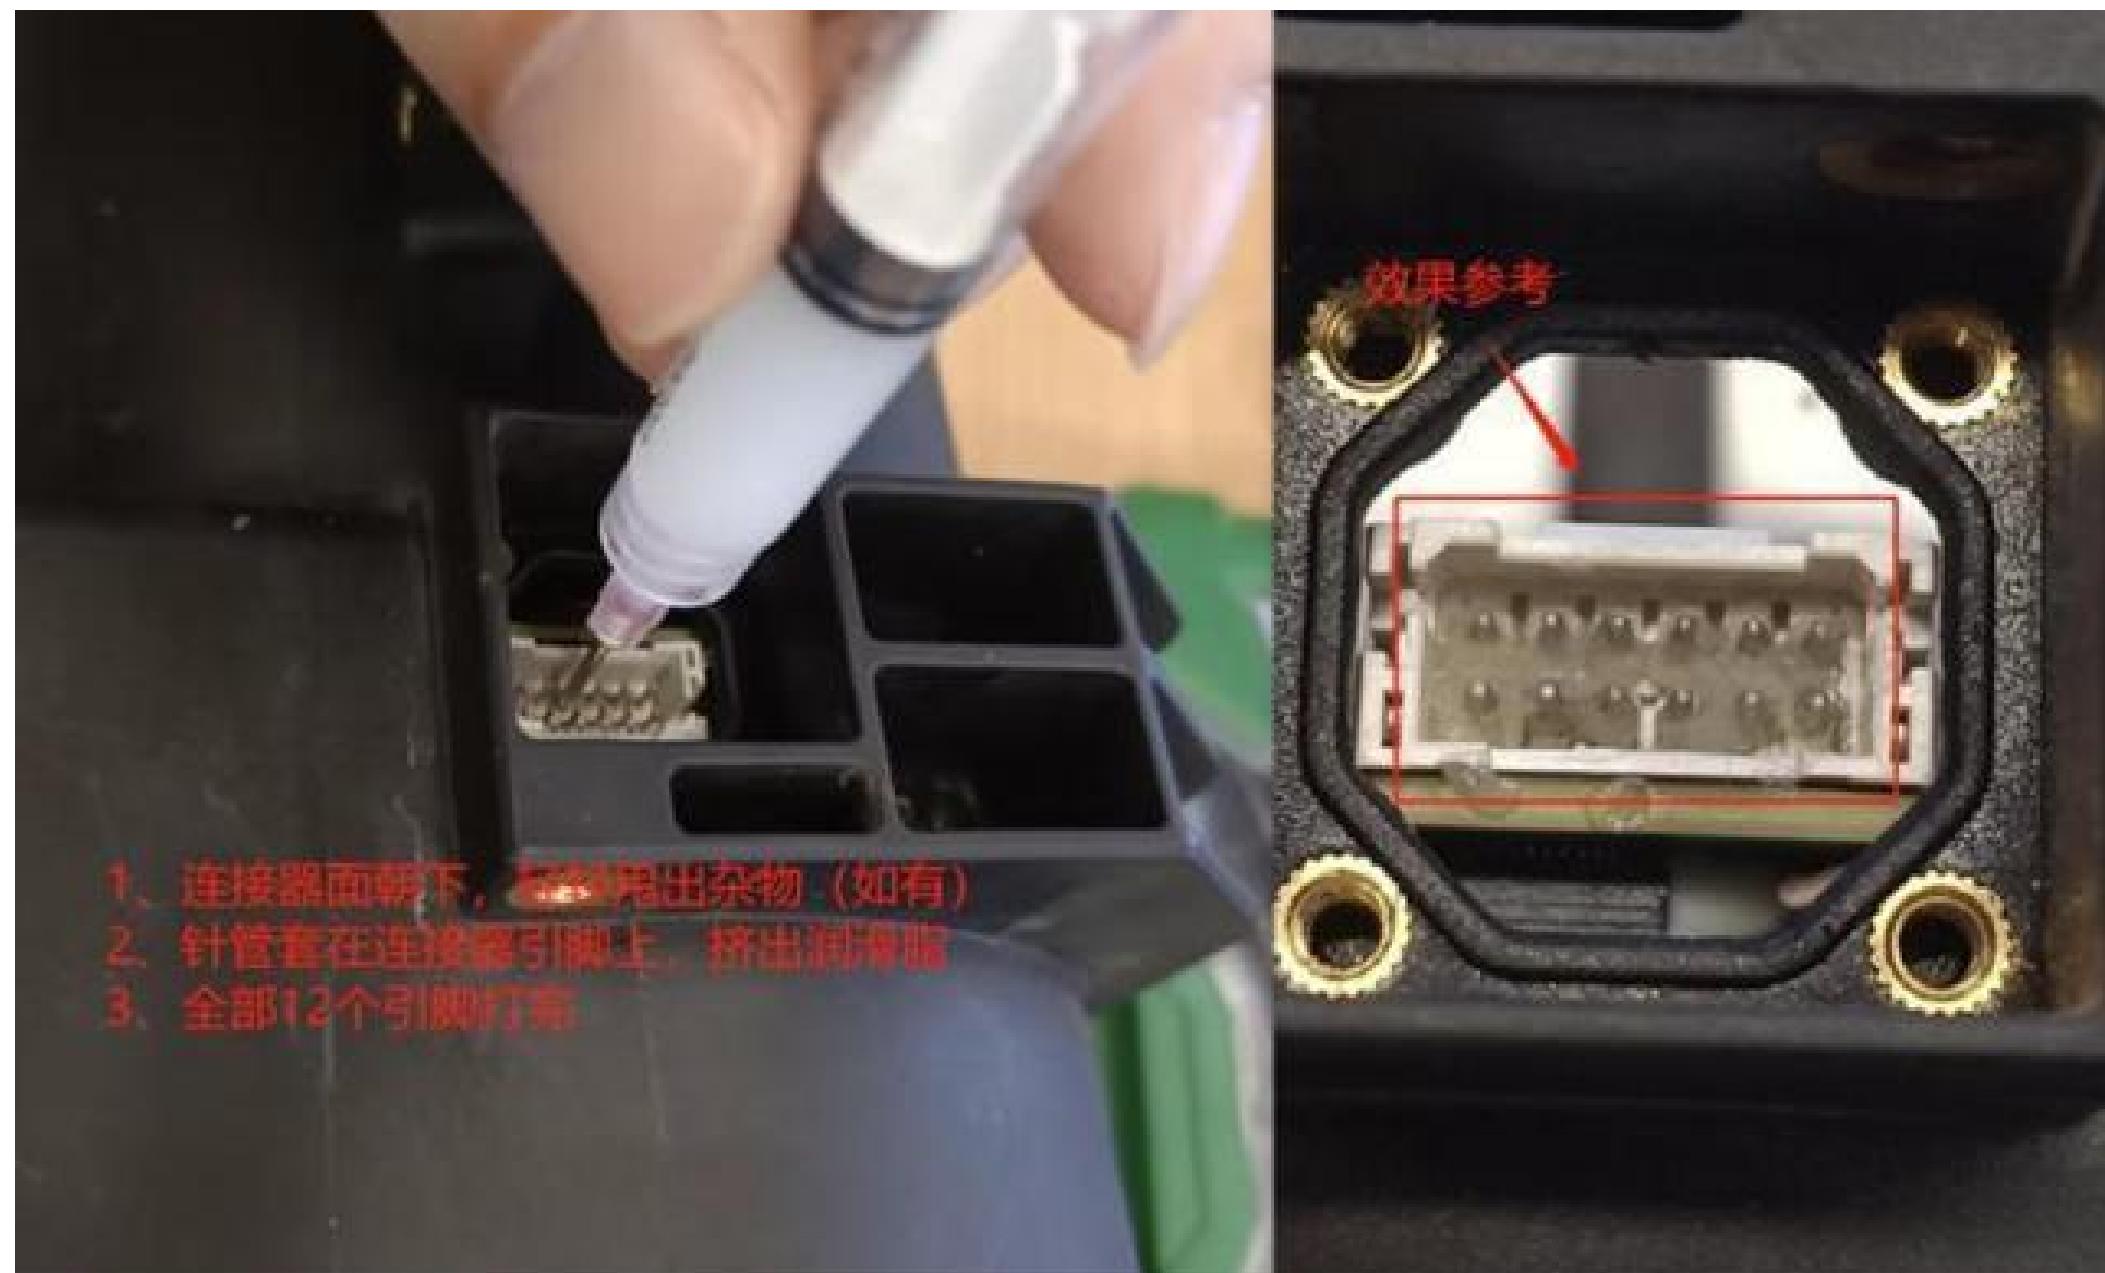
### 2. Plate end connectors greased

2.1. With the connector face down, gently throw out the debris (if any)

2.2. Sleeve the needle tube on the connector pin and extrude the grease

2.3. All 12 pins are punched, please refer to the picture on the right for the effect

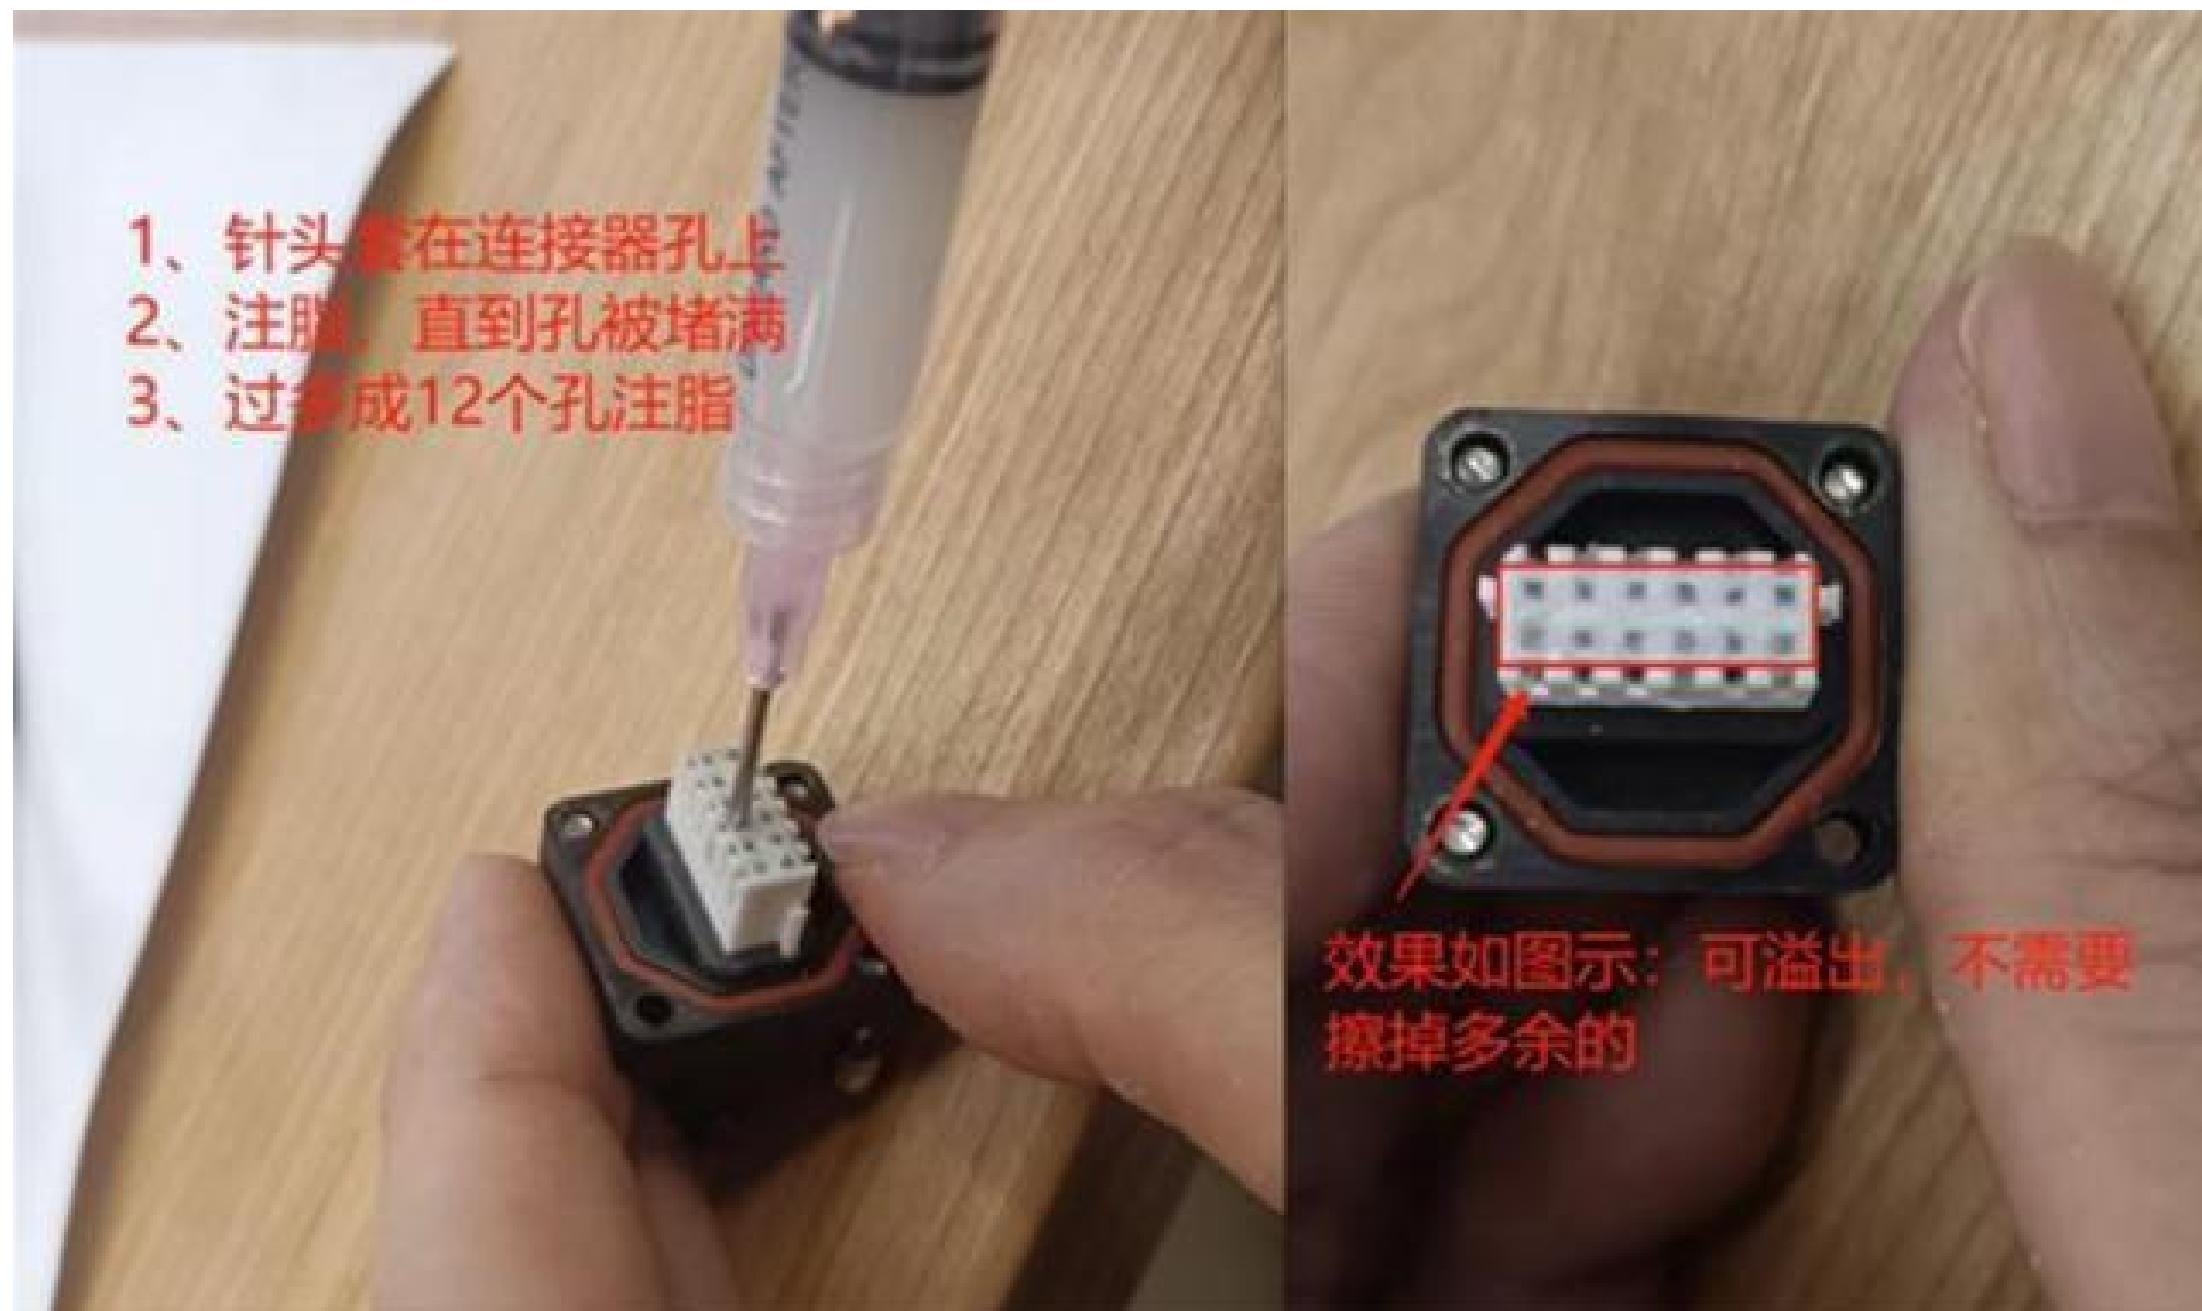
### 3. Grease the wire board connector

#### 3.1. The needle is put on the connector hole

#### 3.2. Inject grease until the hole is filled

#### 3.3. If you have too much grease is injected into 12 holes. The effect is as shown in the picture on the right. It can overflow and there is no need to wipe off the excess

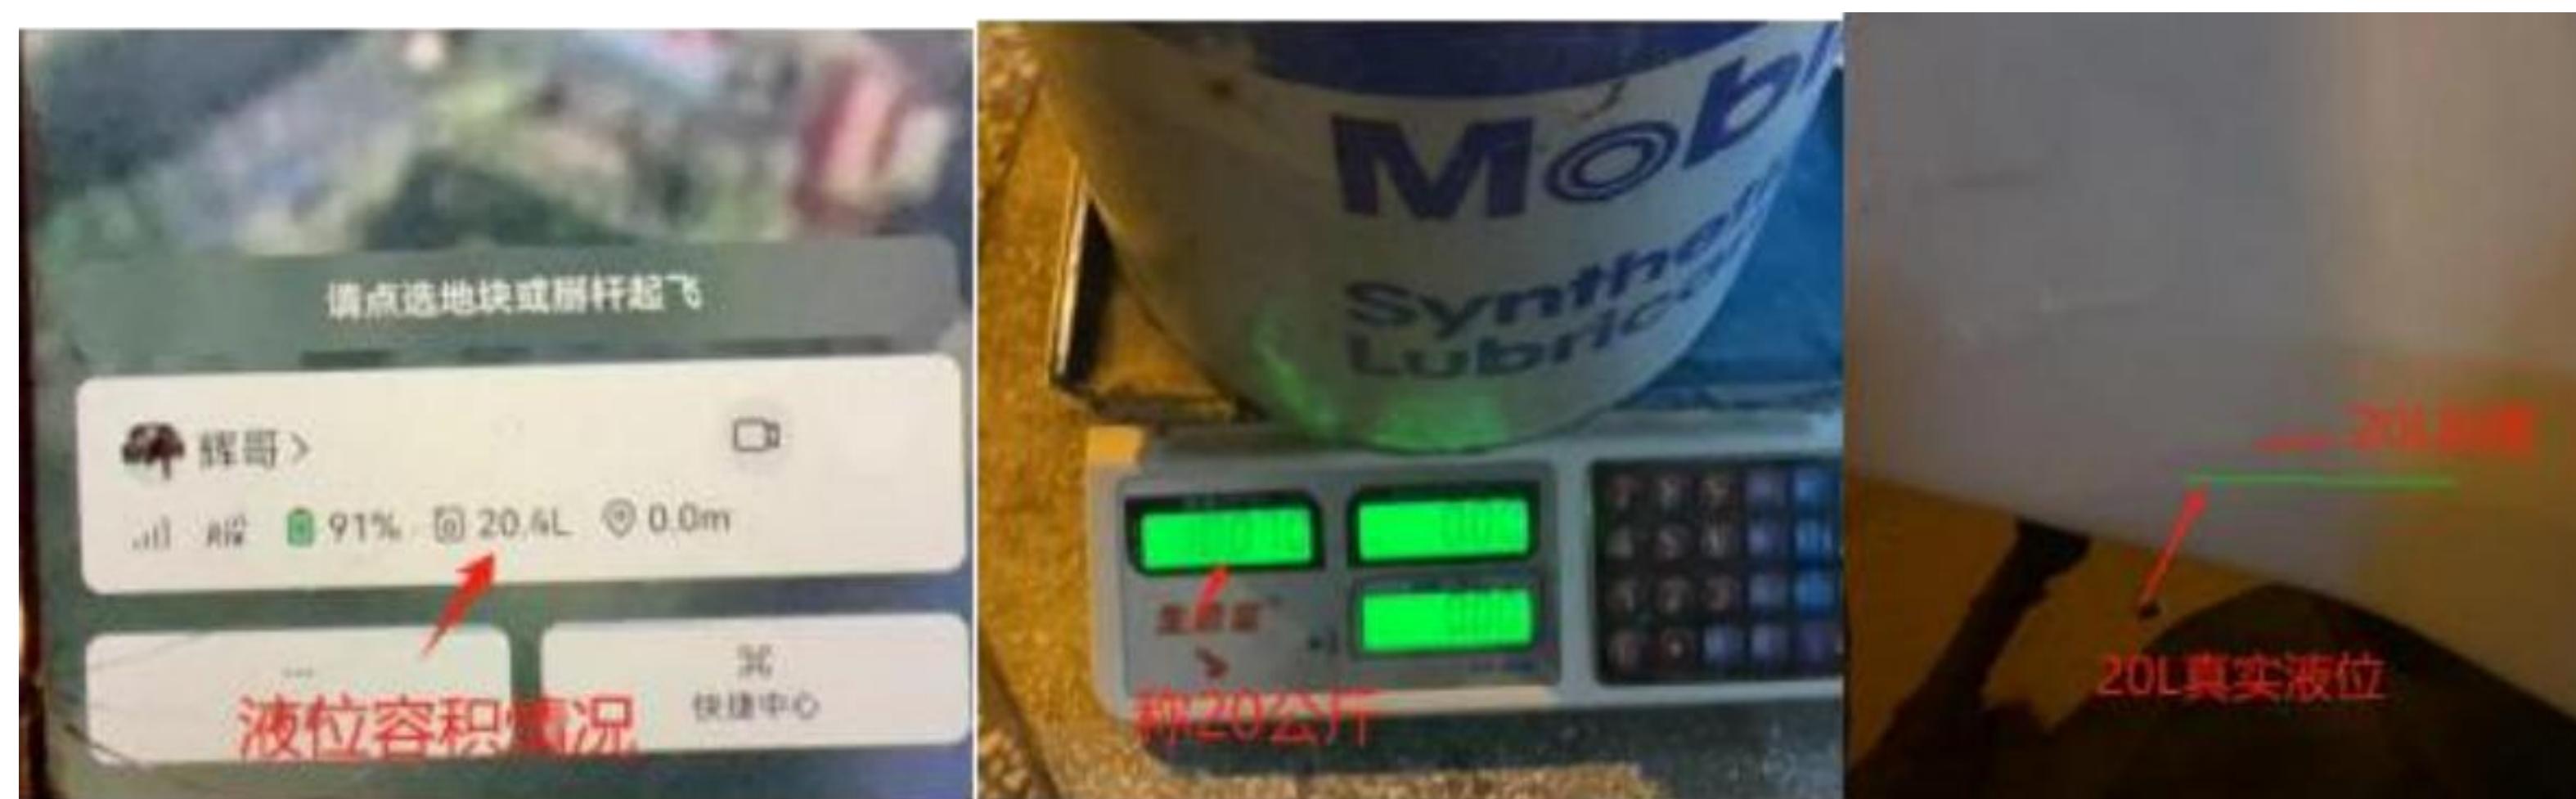
- 1) Confirm that the firmware of payload system and the spraying system have been upgraded to the latest version.
- 2) Please confirm if the reading of the liquid level sensor is accurate. Add 20L of water to the liquid tank and check if the liquid level displayed on the APP is within  $\pm 5\%$  of 20L. At the same time, it is necessary to confirm the deviation of the liquid tank scale. (Due to potential scale marking deviations caused by transportation-induced deformations, please manually measure 20L of water and check if the APP display is accurate, do not rely solely on tank markings).

Attention: If there is a significant deviation, please handle it according to the following methods:

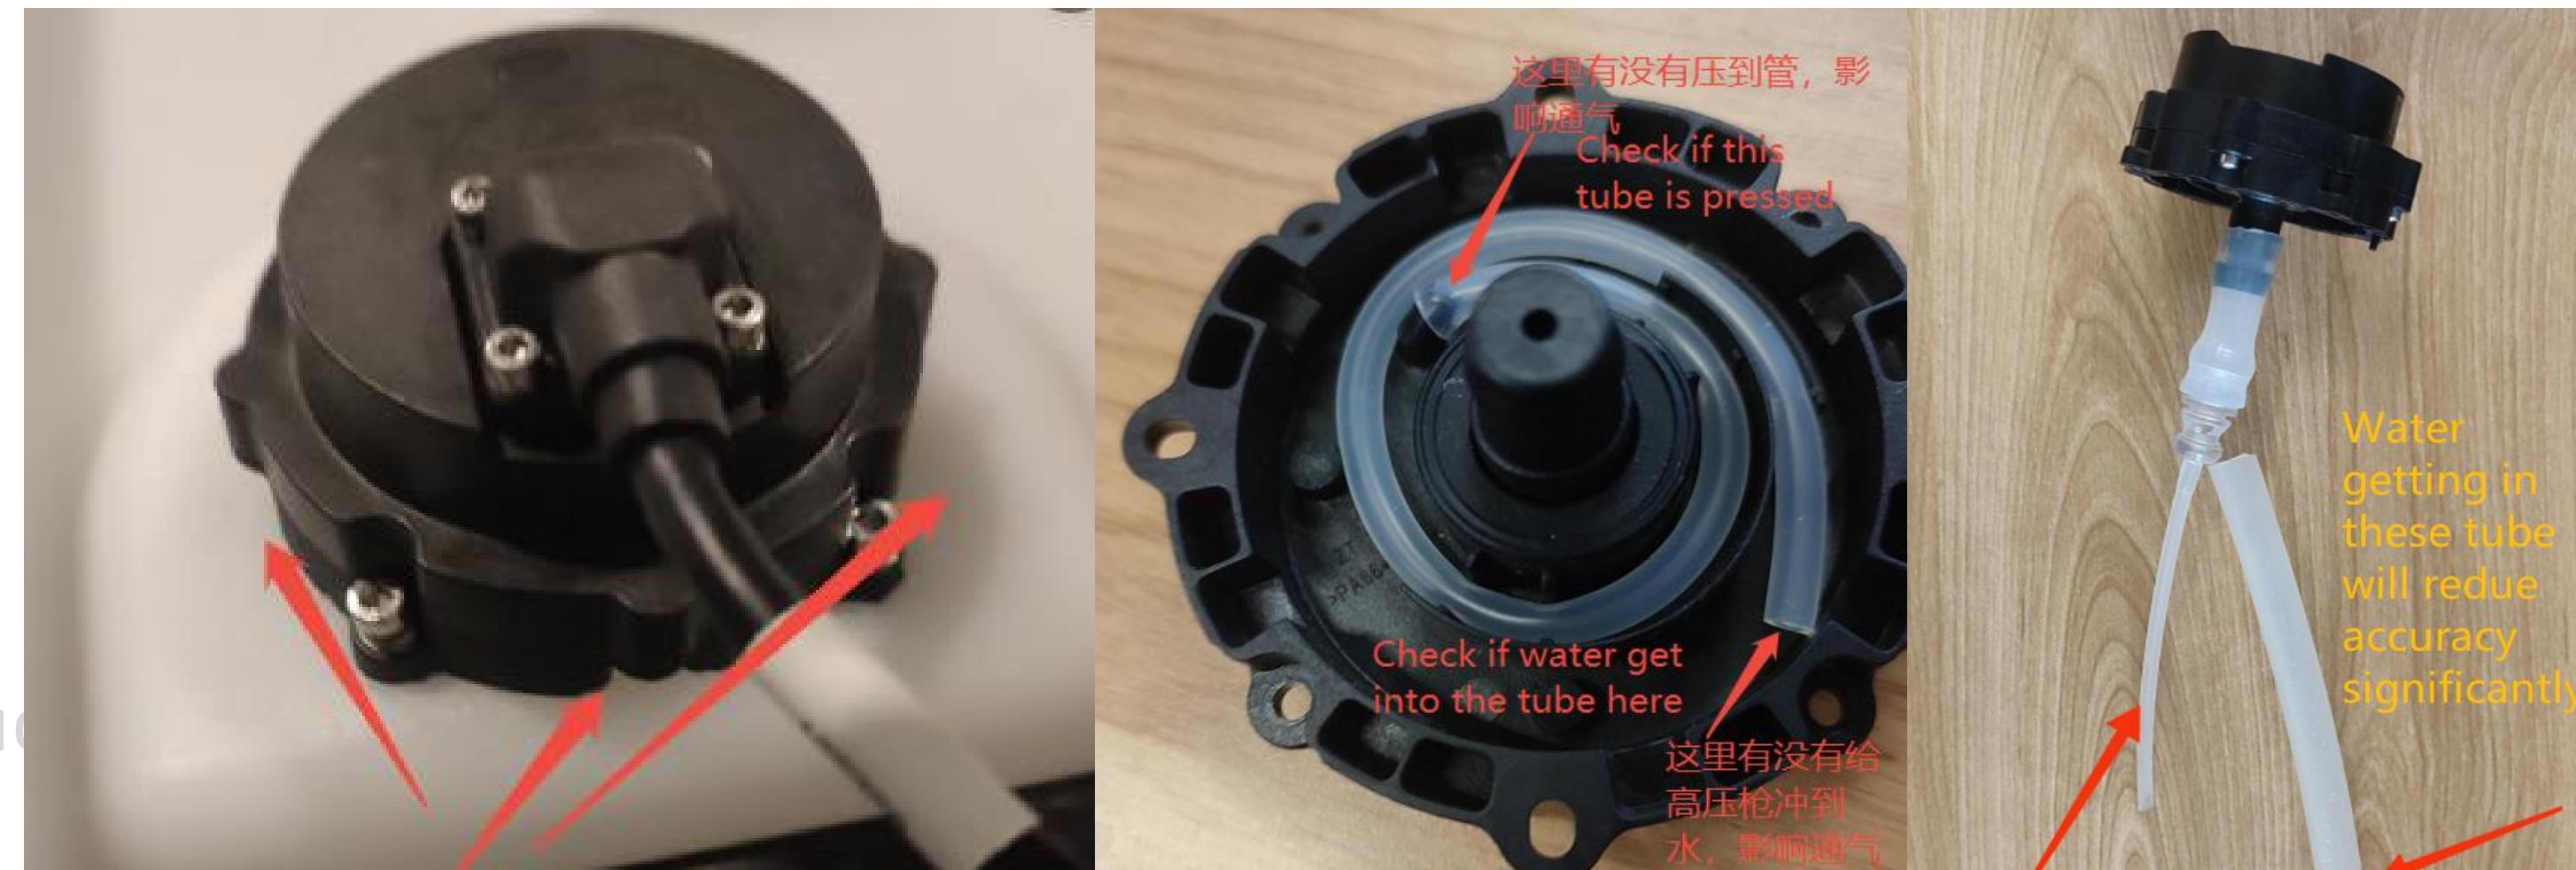
- ① Green light flashing (1 flash per second): Indicates the liquid level sensor is working normally. However, if the APP displays a value other than 0L or less than 1L, it means the positive value is too high, and the capillary tube needs to be disassembled for further inspection.

- ② Red light flashing (1 flash per second): Indicates the negative value of the liquid level sensor is too high, likely due to water in the capillary tube that needs to be dried.

- ③ Green light always on: Indicates abnormal communication of the liquid level sensor. Check or replace the air pressure PCBA board.
- ④ Red light always on: Indicates abnormal CAN communication. Check the connection wires between the spraying junction box and the liquid level sensor, as well as between the headstock junction board and the spraying junction box for looseness or damage.

- ⑤ Light off: Indicates abnormal power supply. Check the power supply circuit.

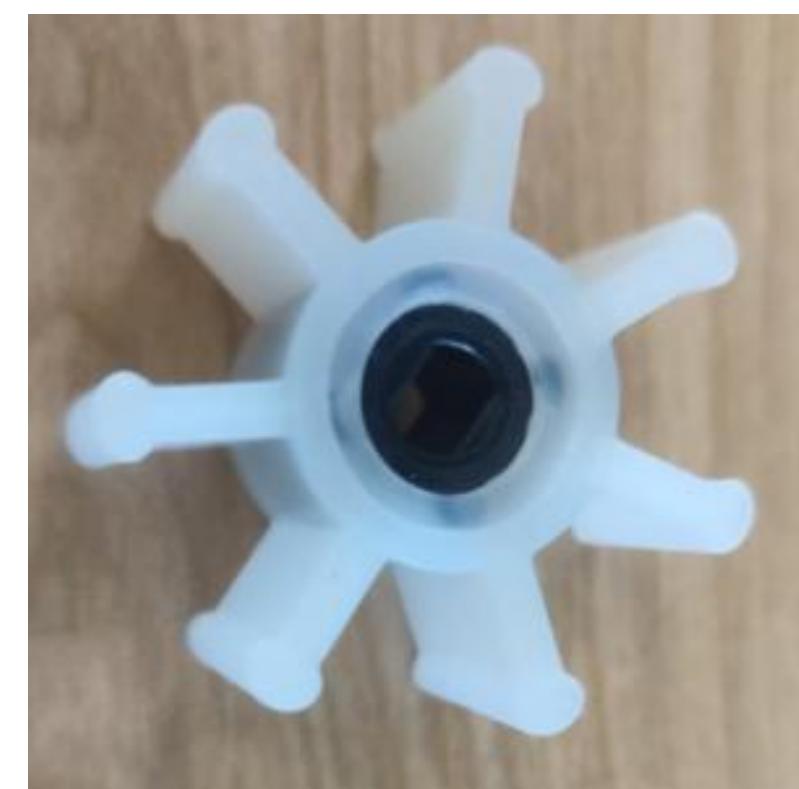
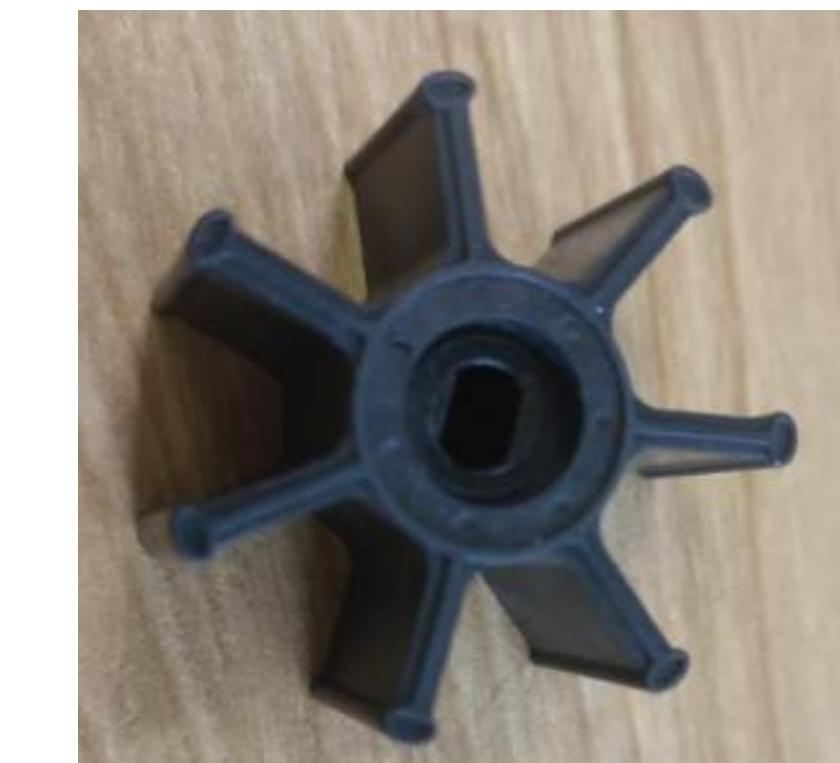
① Low-temperature characteristic impeller, light gray, suitable for use when the ambient temperature is below 15°C;

② Strong chemical-resistant impeller, black, with high chemical and corrosion resistance, suitable for use when the ambient temperature is above 15°C.

--Usage tips: This type of impeller is not as resistant to chemicals. If it is a newly replaced impeller, during calibration, you can unplug the pipe connected to the machine body for calibration. Alternatively, after the impeller has been operated for 3.3 hectare or 3 shifts, when the impeller has swollen to a certain extent, perform secondary calibration, which will be more accurate.
